TECHNICAL REPORT

IRANIAN AM-50

12.7 × 99 MM

ANTI-MATERIEL RIFLE

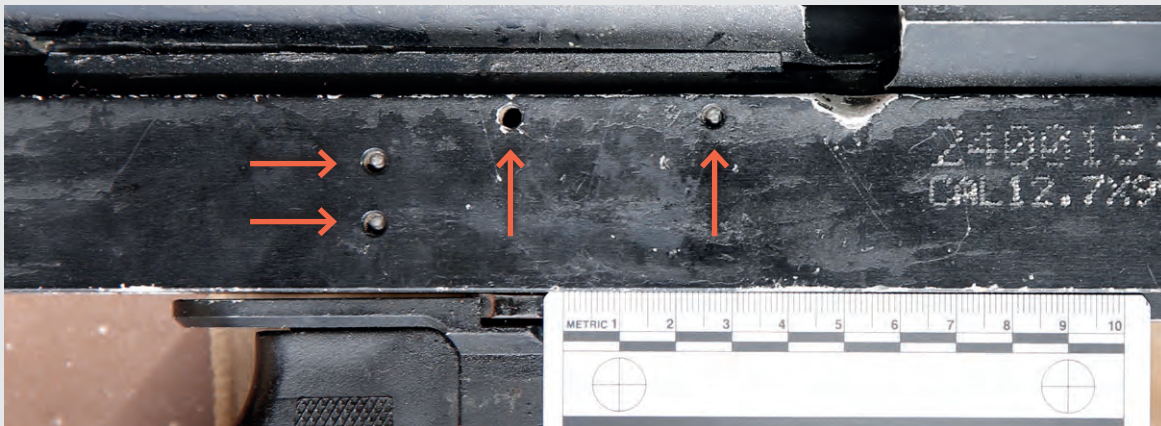
The AM-50 receiver group is composed of an aluminium housing that is painted black (see Figure 3). The trigger group sits in the housing and is retained in place by four pins (see Figure 4). A trigger guard is screwed to the housing from beneath (see Figure 5).

Figure 4
Three of four pins designed to retain the trigger group within the housing (see arrows)

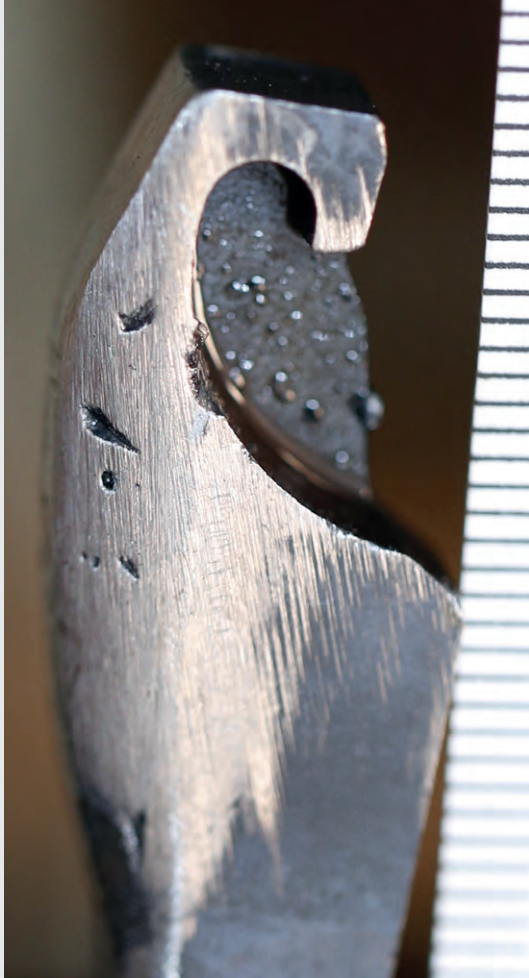
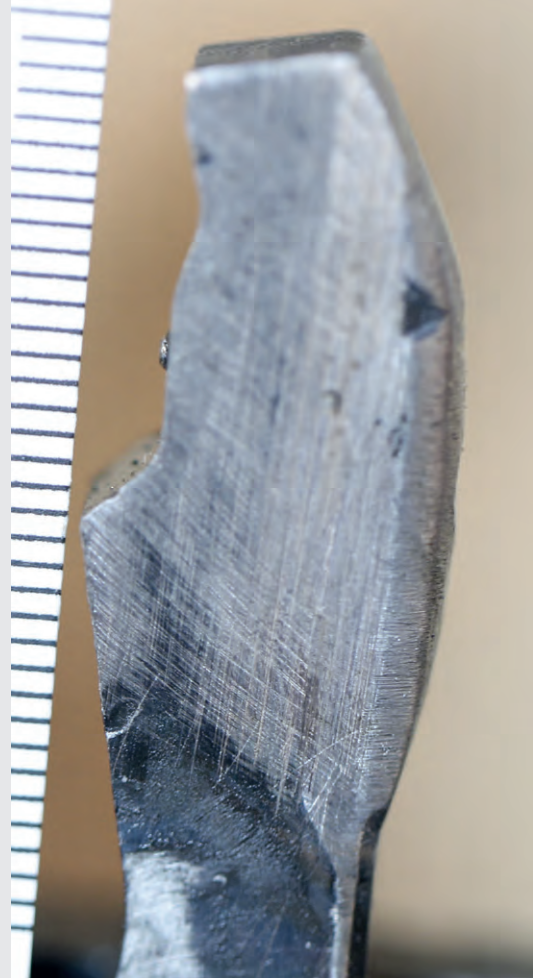
The hammer on the rifle appears to have been roughly filed to permit fitting (see Figures 6 and 7). It is not possible to determine whether the filing occurred before or after assembly by the manufacturer.

Figure 6
Hammer (left-hand side), displaying tool marks

Figure 7
Hammer (right-hand side), displaying tool marks

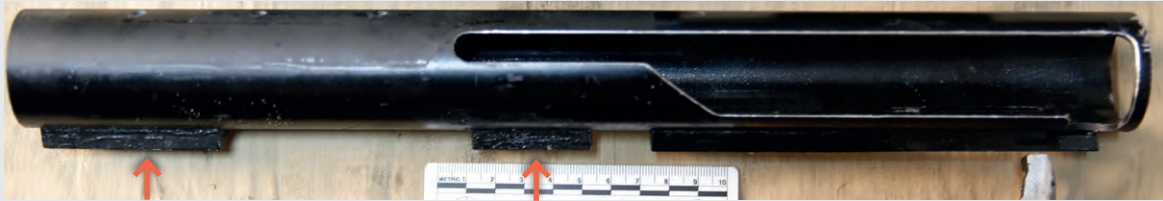
Figure 12
Tube housing sub-assembly

The tube housing sub-assembly features spacers (see the arrows in Figure 12) and an opening to allow for the movement of the bolt and guide tube sub-assembly. The tube housing sub-assembly is also open at the bottom, to allow the hammer to strike the firing pin (see Figure 13).

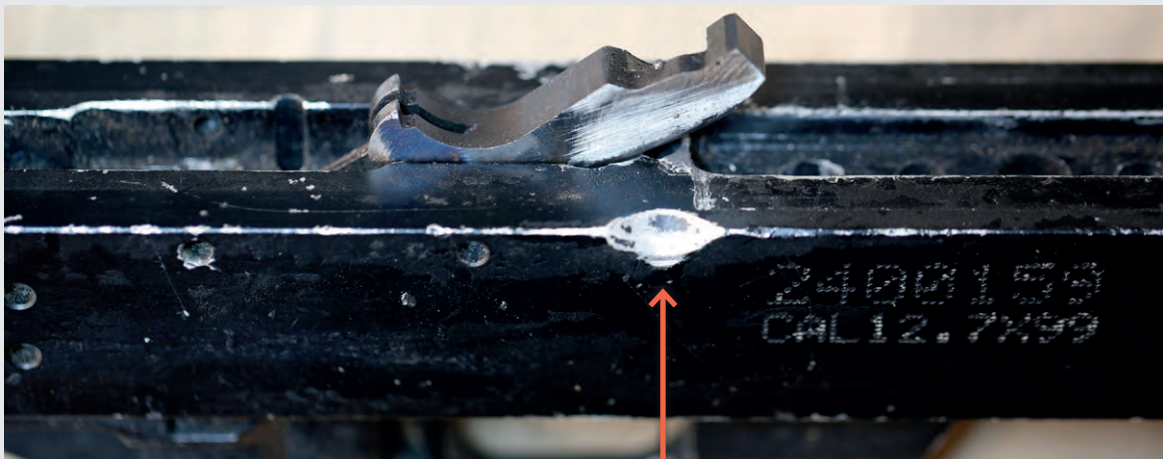
The weapon exhibits visible damage to the housing, which may have been caused by repeated or improper use of the bolt handle, or by poor design (see the arrow in Figure 14).

Figure 14
Damage on the right-hand side of the housing, against which the bolt handle rests when the bolt is closed

The surface treatment of the recovered AM-50’s aluminium and steel components was poorly executed. The steel components of the weapon appear to have received a ‘bluing’ finish on surfaces that retain imperfections from milling and other tooling marks. The finish indicates low-quality surface preparation, which renders some components prone to premature corrosion. Furthermore, the weapon’s aluminium components do not appear to have been adequately polished prior to being anodised—a process that is regulated within the quality

control standards employed by modern weapon manufacturers (see Figure 14, for example). Sections of exposed aluminium around the dot-peened serial numbering also suggest that the coating failed to adhere to the aluminium and was later dislodged during the marking process. In addition, it is possible that the weapon’s manufacturer did not treat metal surfaces with surface cleaners prior to painting and left untreated aluminium surfaces exposed to the atmosphere for too long, rendering them vulnerable to aluminium oxidation prior to anodising.

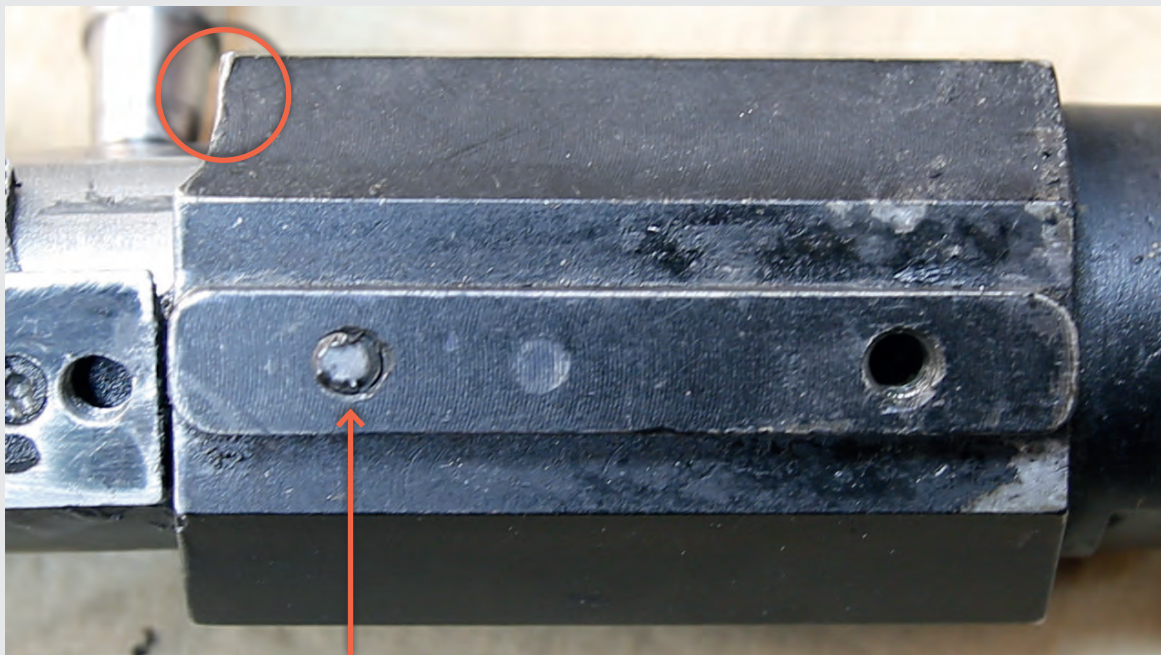
Figure 15
Underside of the barrel showing thread holes

The rear screw in the underside of the barrel is broken in its hole (see the arrow in Figure 15). Damage is also visible on the breech block, which the bolt has repeatedly struck on its return to battery (circled).

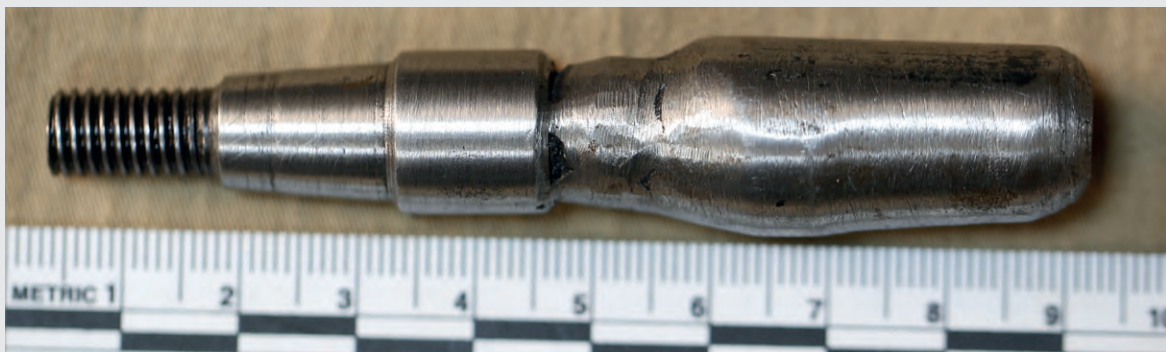
Figure 26
Replacement bolt handle

The bolt handle has been sheared off and replaced, possibly because excess force was applied to open the bolt following a jamming event. Efforts to pry open the bolt, either through percussive force or leverage, place tremendous stress on this relatively fragile component and breakages are common without proper operator training and access to qualified armourers. A replacement bolt handle was welded or brazed to the remaining stub of the bolt handle assembly and then hand-finished (see Figure 26).

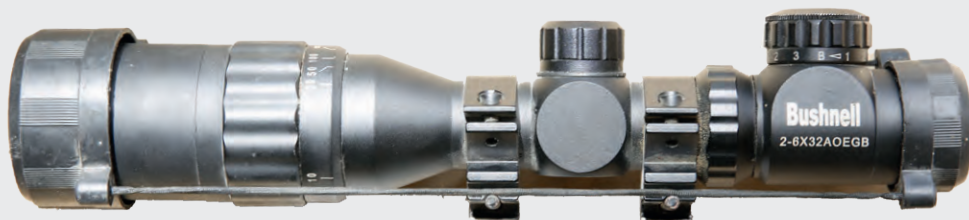
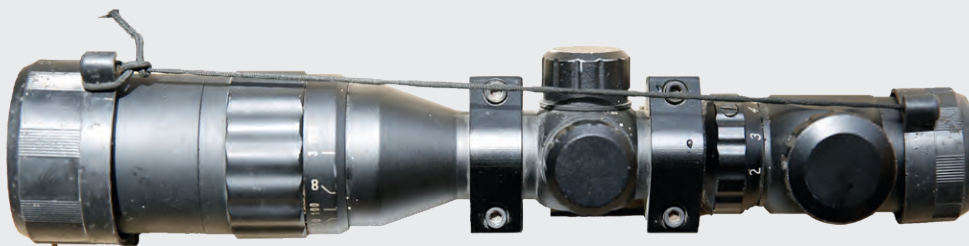
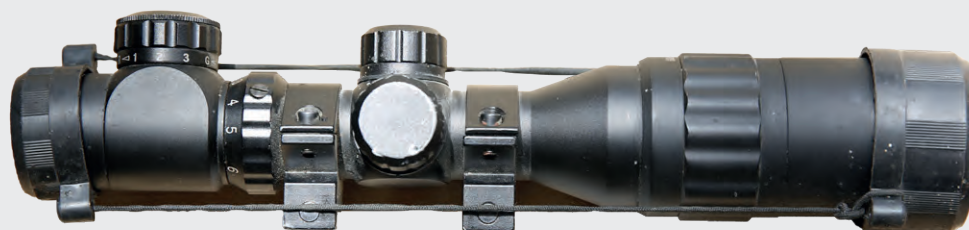
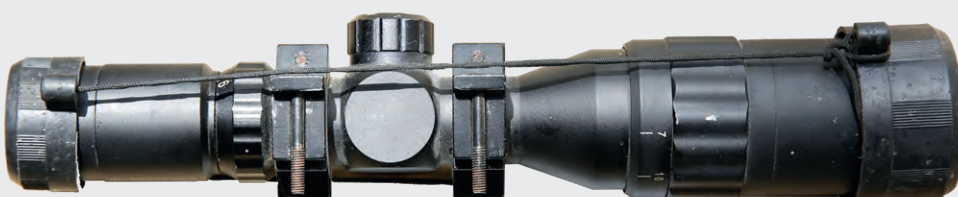
Figures 27, 28, 29, and 30

The AM-50 rifle documented by CAR was fitted with a Bushnell 2-6 × 32 telescopic sight. Analysis of the sight indicates that the device is a low-cost, civilian sporting unit designed for air rifle shooting and that it is unlikely to withstand the recoil forces encountered when a 12.7 × 99 mm cartridge is fired in a normal military setting (see Figures 27–30).³ The parallax adjustment ring, towards the front of the scope, is numbered from a distance of 3 yd (2.7 m), which is a standard feature of air rifle telescopic sights, as short-range precision is necessary for some forms of target shooting and hunting.

CAR concludes that the fragility of the telescopic sight and mounts, the relatively low magnification (a range between 2x and 6x), and the small objective size (36 mm) reduce the effective accurate range of the weapon system and its functionality in low-light conditions. The effective range of the weapon against personnel would, at best, match the effective range of a modern assault rifle.

Optical sight: left-hand side (Figure 27); top (Figure 28); right-hand side (Figure 29); underside (Figure 30)

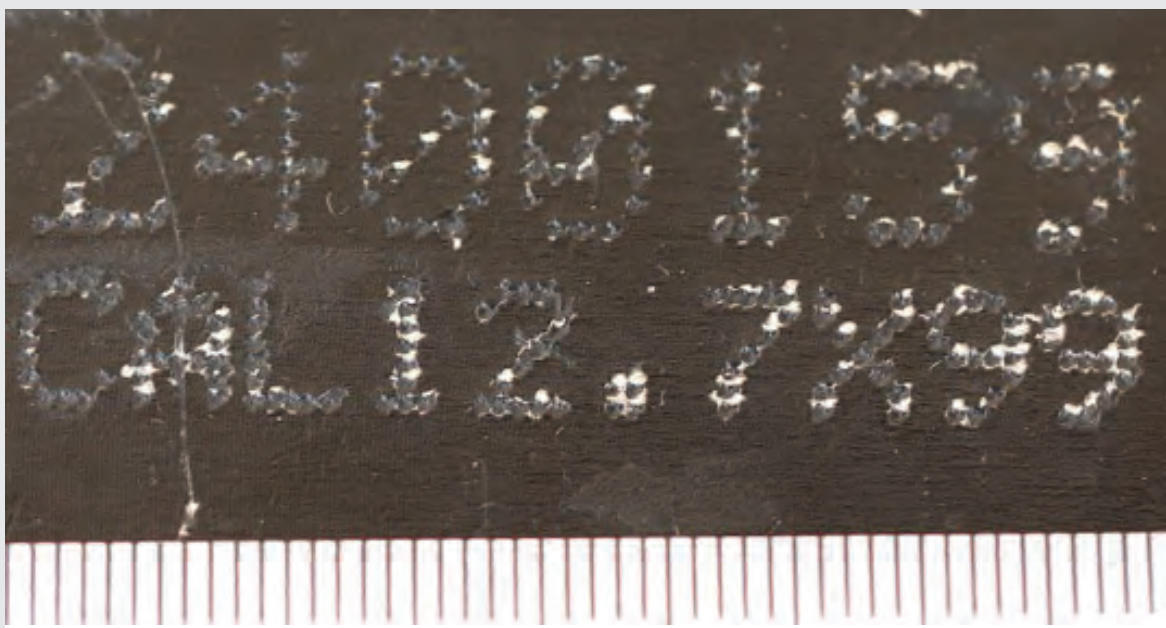
Figure 31
Mark #1

Mark #1, the weapon's primary serial number, seems to have been applied at the end of the assembly process (see Figure 31). The manufacturer probably applied this mark after having anodised the aluminium housing. It is likely that this anodising process occurred without sufficient surface preparation. The resulting poor finish impeded surface adhesion during the anodising process. By contrast, more advanced assembly processes add dot peen marks prior to anodising, which ensures more complete surface coverage and greater surface wear resistance and protection.

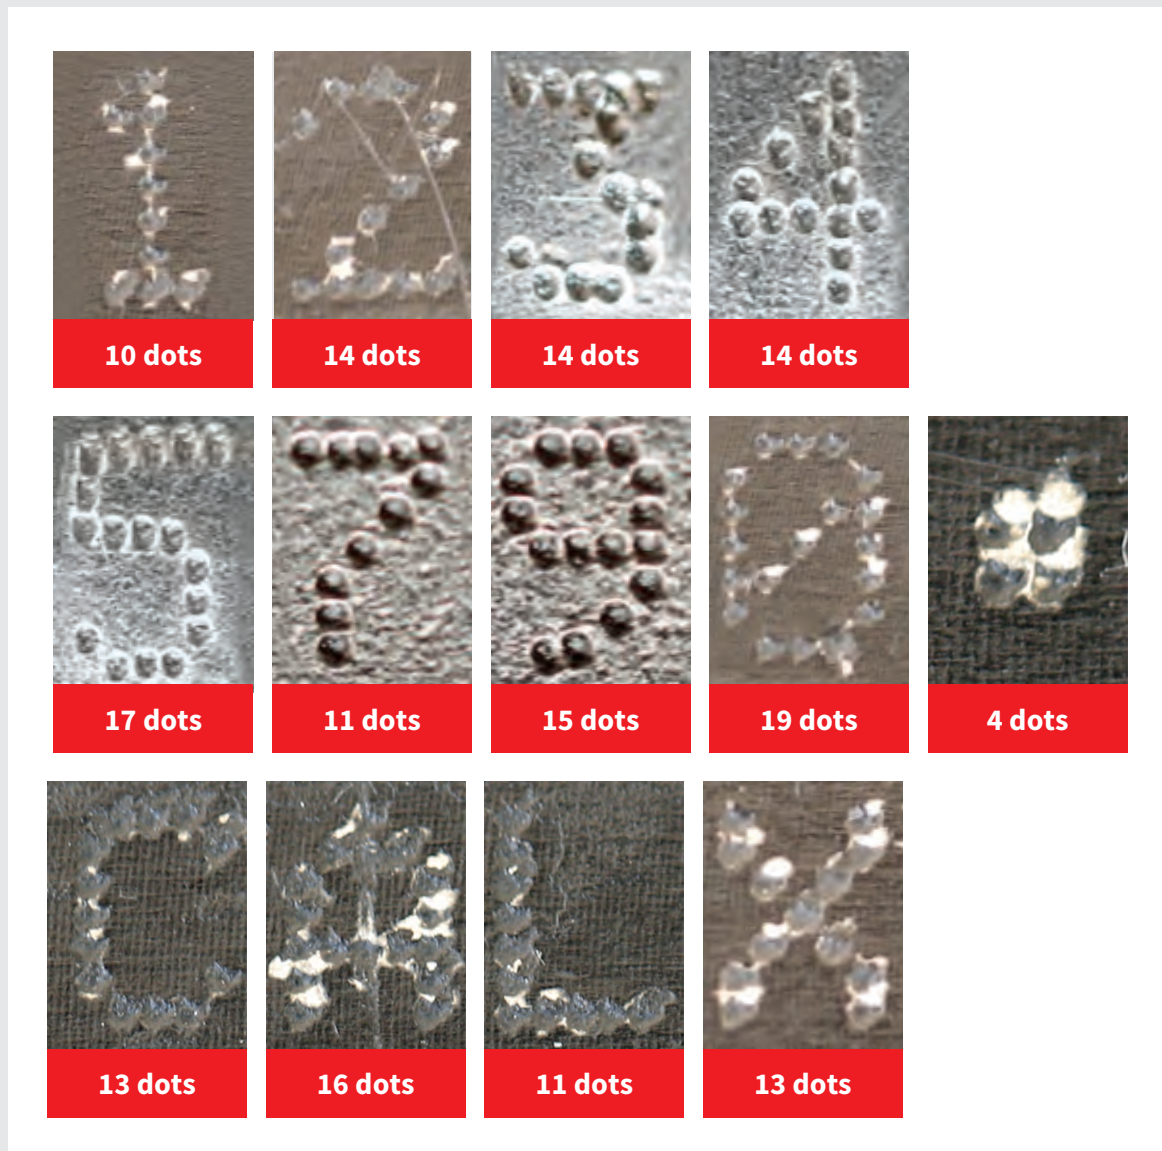
Figure 32
Dot count for documented marks

Dotpeen machines can be programmed to adjust a series of parameters, such as strike energy, font size, spaces between dots, and characters per centimetre. A more thorough investigation, based on dotpeen marks, would require forensic photographic equipment. However, the methods of documentation employed for this investigation allow for counting dots in the characters of some of the marks, which may provide a useful metric for the analysis of weapons manufactured in Iran (see Figure 32).
