TECHNICAL REPORT

IRANIAN AM-50

12.7 × 99 MM

ANTI-MATERIEL RIFLE

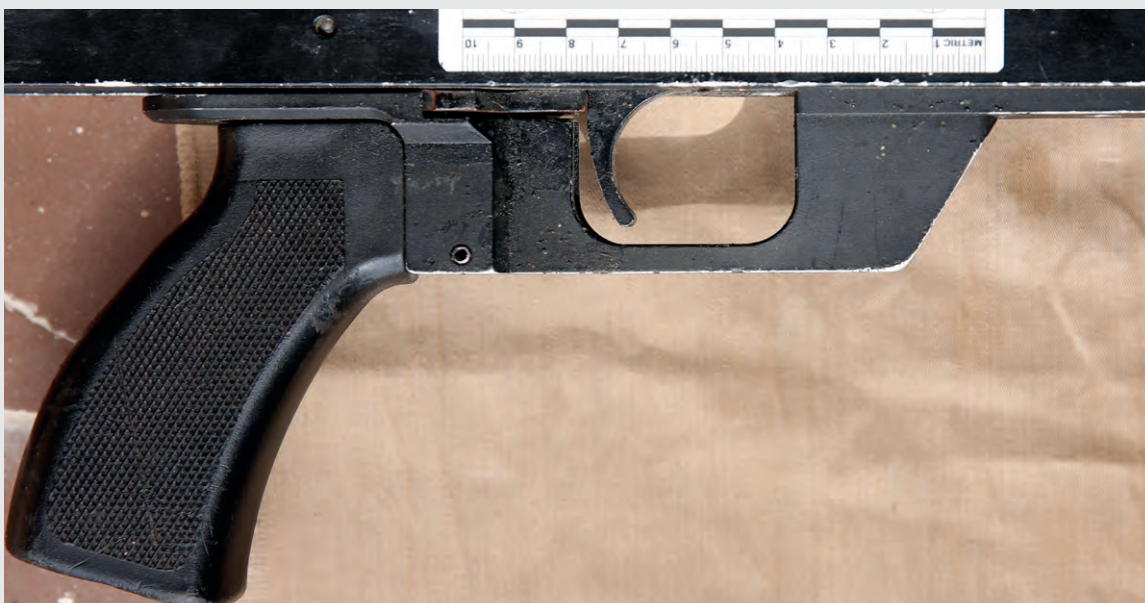
Figure 5
Trigger guard, trigger, safety, and pistol grip

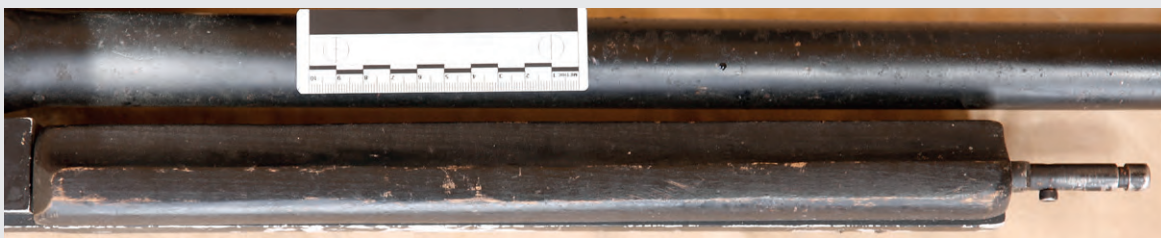
A wooden forearm is attached to the front of the housing. At the end of the forearm is a bipod stud (see Figure 8). The rifle does not have a bipod attached to the stud.

Figure 8
Wooden forearm and bipod stud

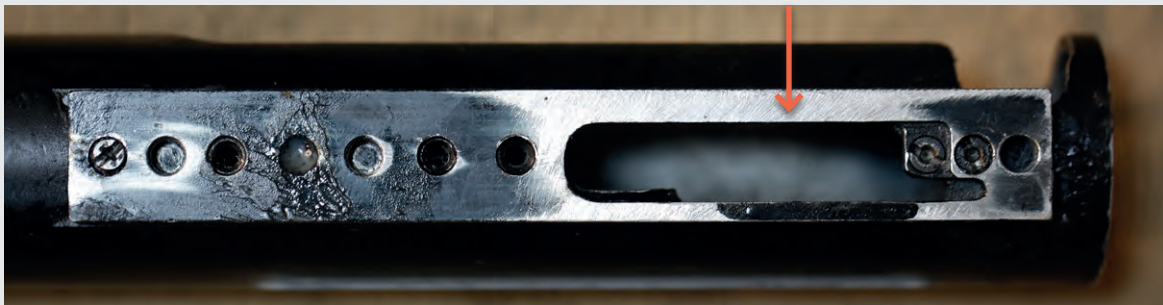
The tube housing sub-assembly features spacers (see the arrows in Figure 12) and an opening to allow for the movement of the bolt and guide tube sub-assembly. The tube housing sub-assembly is also open at the bottom, to allow the hammer to strike the firing pin (see Figure 13).

Figure 13
Tube housing sub-assembly (bottom view) with an opening (arrow) that allows the hammer to strike the firing pin

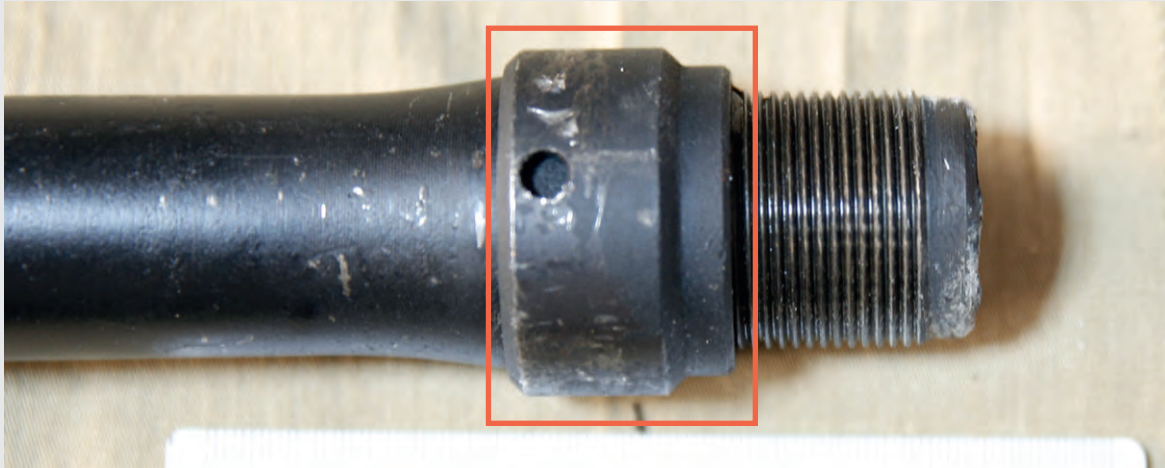
A locking nut (highlighted in Figure 16) is fixed to the barrel at the rear of the threaded section of the muzzle.

Figure 16
A locking nut fitted to the barrel (see highlighting)

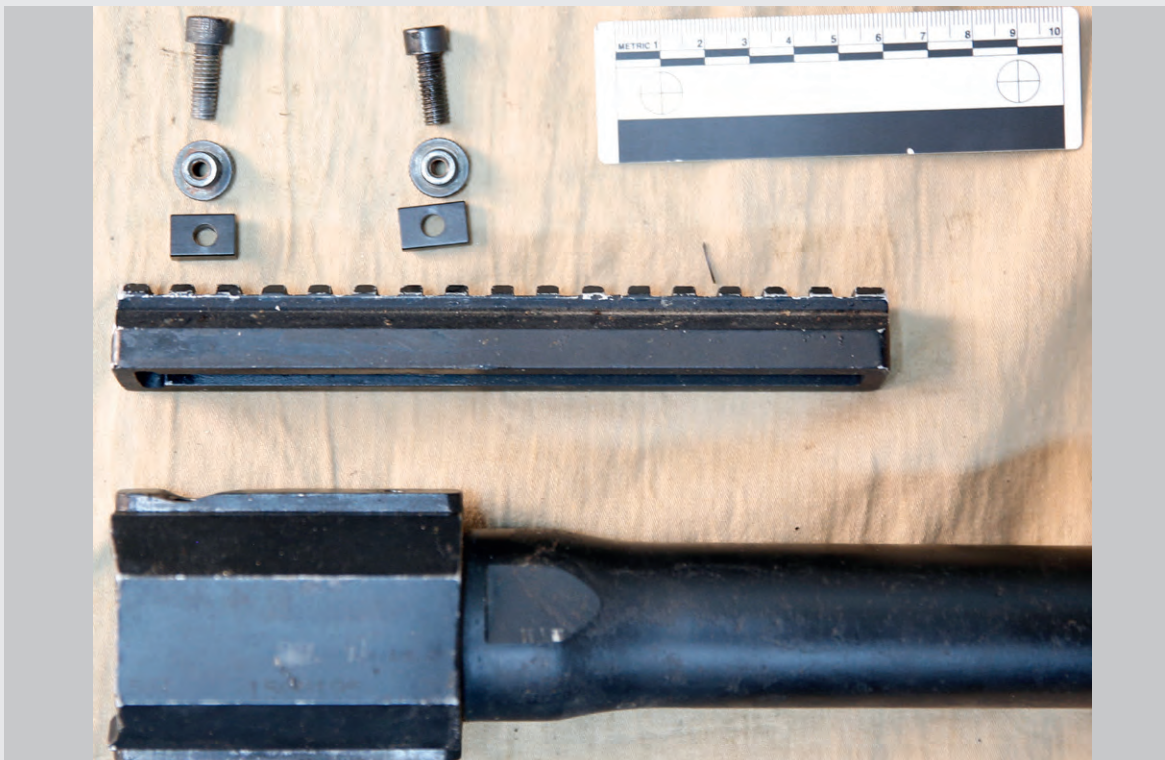
A scope rail sub-assembly is fastened to the top of the barrel with two hex-head cap screws (see Figure 17).

Figure 17
Scope rail sub-assembly with the two screws that are used to fasten it atop the barrel and two fasteners for the optics

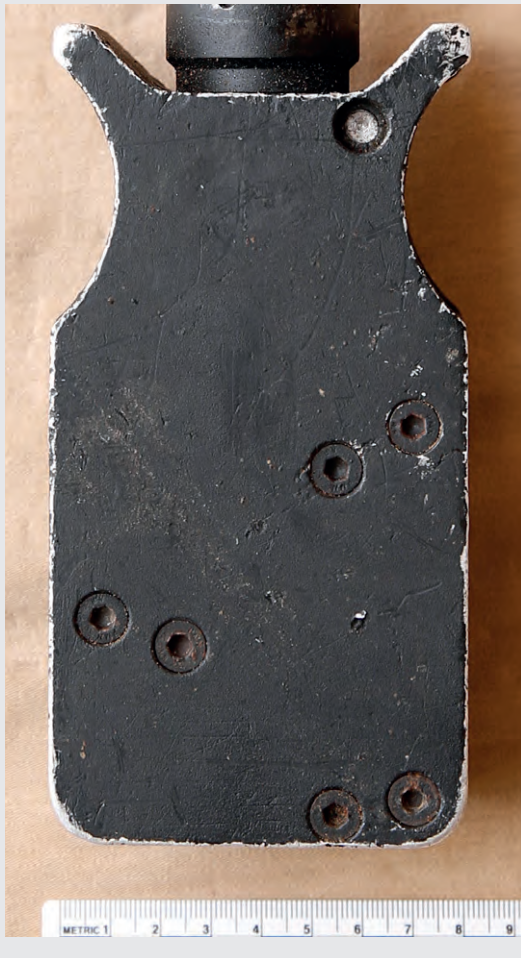
Figure 18
Underside of the muzzle brake with six hex-head cap screws (distributed in three pairs for each vent) and an additional headless screw

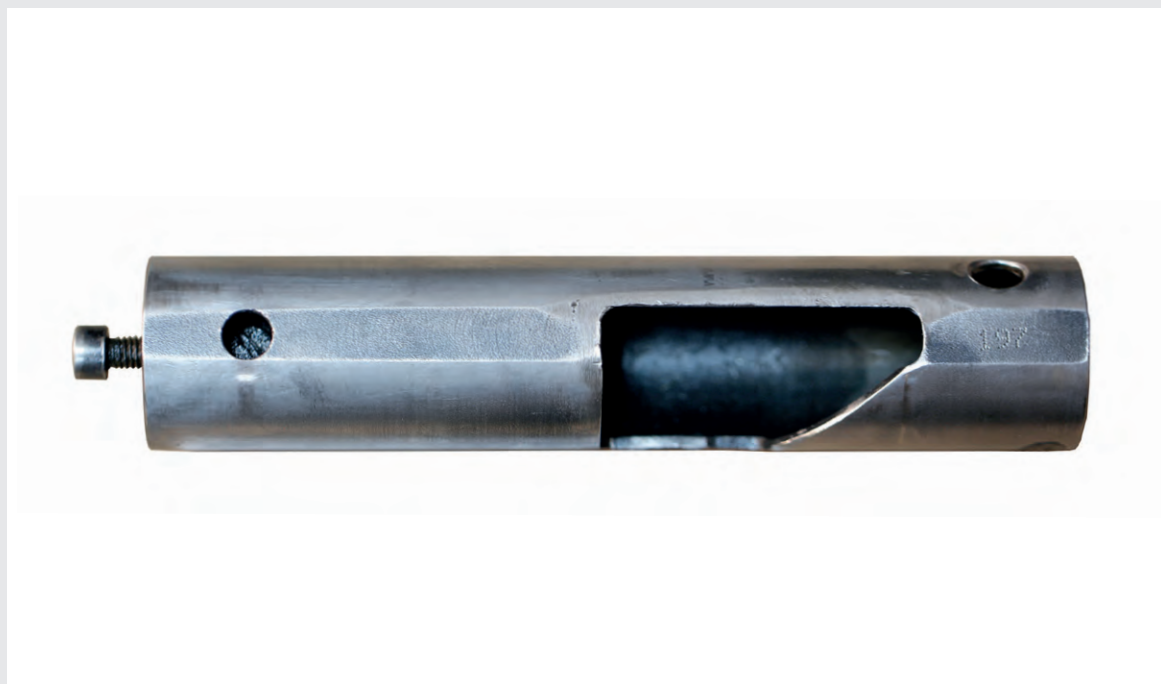
The bolt body slides into the guide tube sub-assembly (see Figure 22).

Figure 22
Guide tube sub-assembly

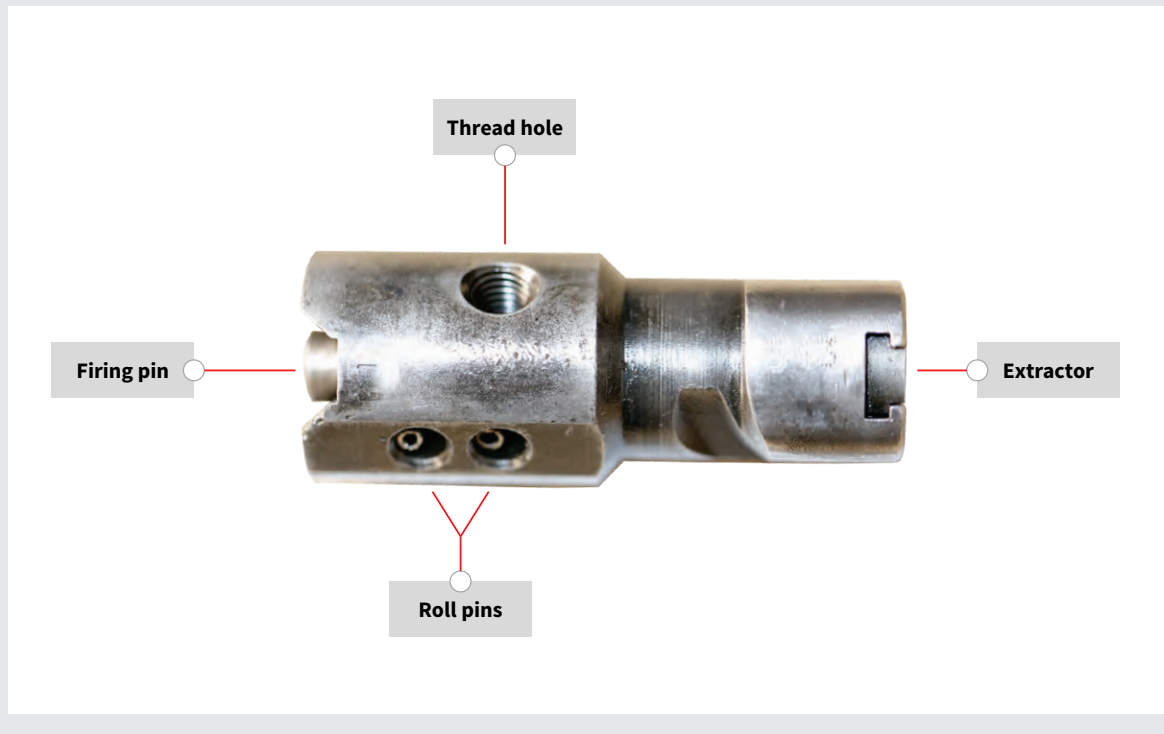
The AM-50 bolt features two roll pins to retain the firing pin (see Figures 23–25).

Figure 23
Profile of the bolt, showing the bolt-handle thread hole, extractor, roll pins, and the rear of the firing pin

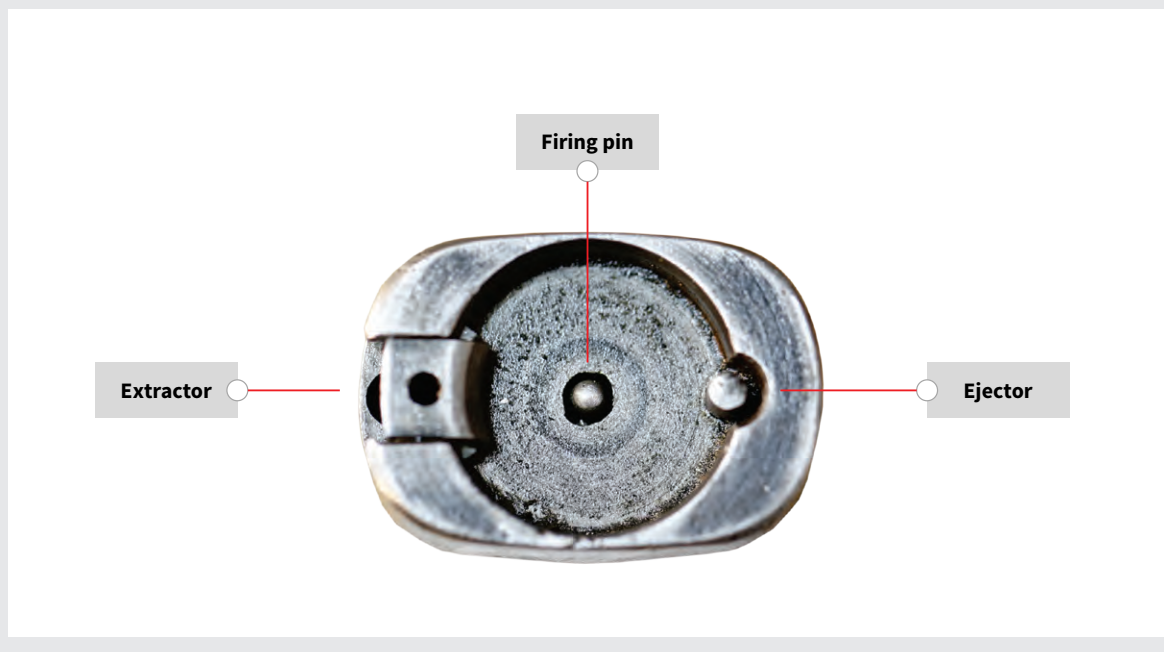
Figure 24
Bolt face, showing the firing pin, ejector, and extractor

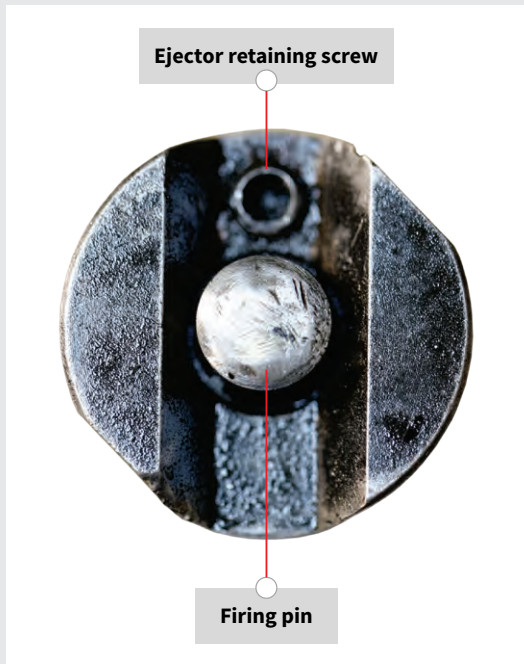
Figure 25
Bolt rear, showing the ejector retaining screw and the rear of the firing pin

There is no visual indication that the headspace has been adjusted. There are no post-production tool marks on the bolt lug, deformations of the exterior parts of the breech area, or barrel flats, which would have resulted from barrel removal processes.

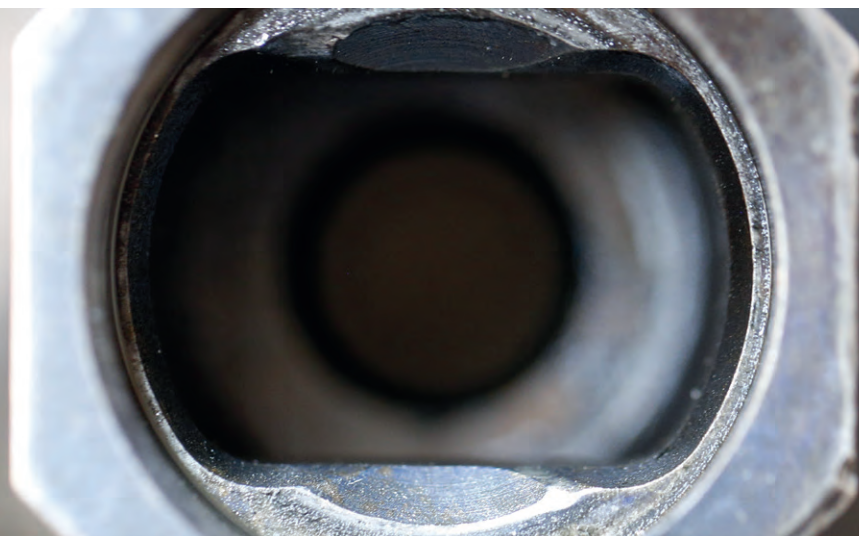
Detail of an AM-50 chamber, showing the locking lugs.

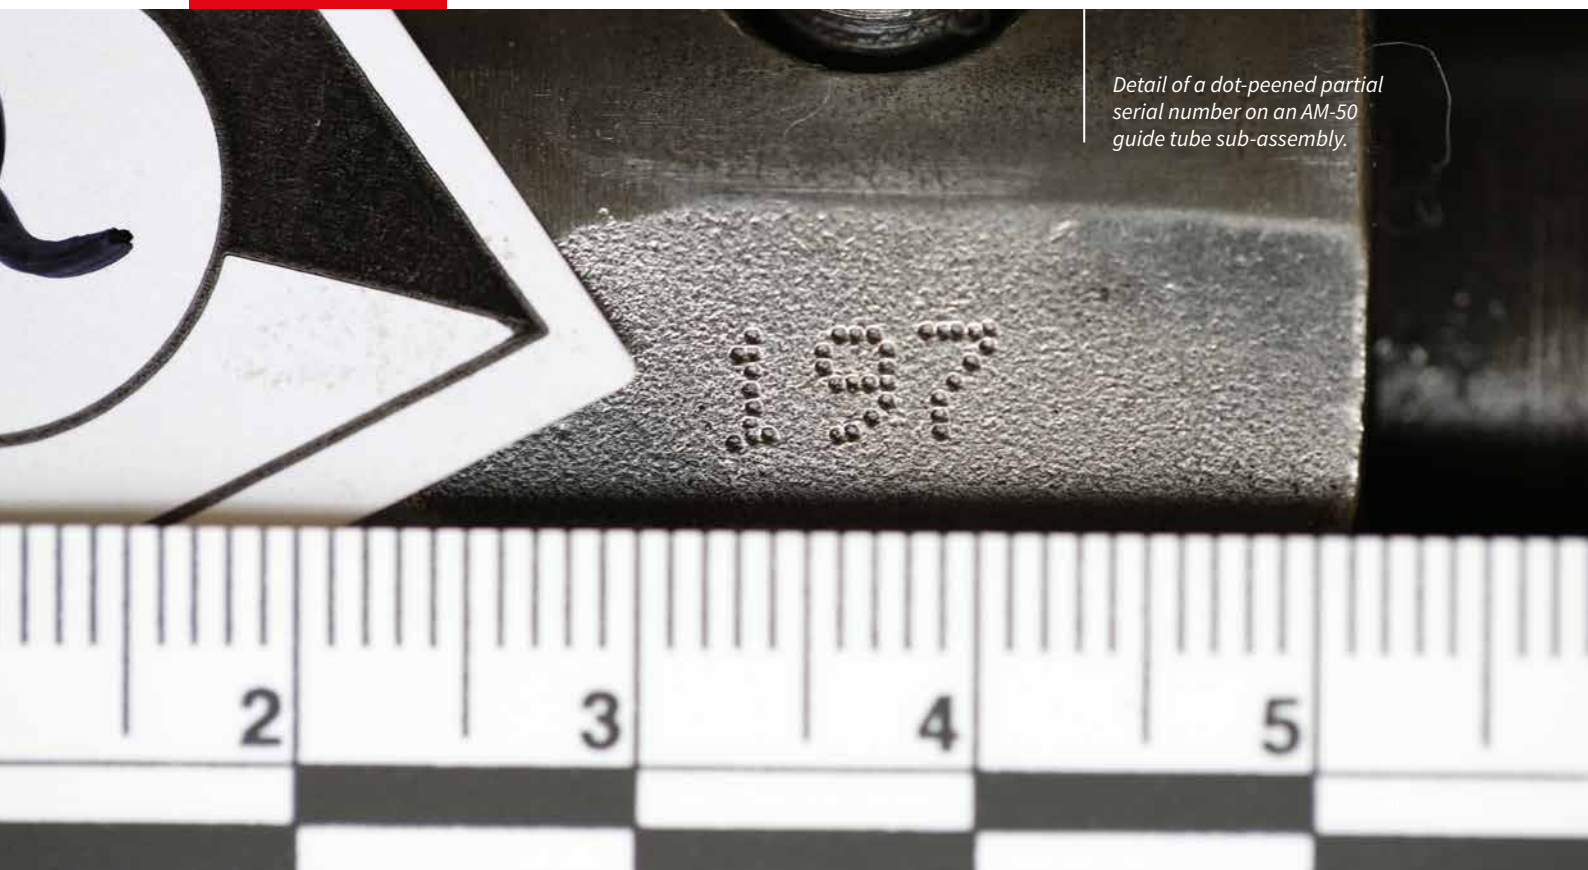
Detail of a dot-peened partial serial number on an AM-50 guide tube sub-assembly.
